United States Department of the Interior
National Park ServiceNational Register of Historic Places
Registration Form

historic name WHITE HOUSE FARM

K-203

GENERAL DESCRIPTION:¹

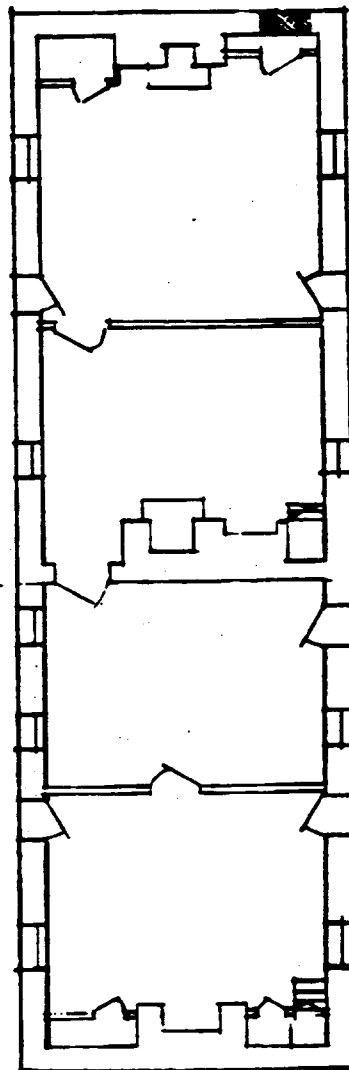
WHITE HOUSE FARM (K-203)
Kent County, Maryland

Period 1

Period 2

sketch plan
not to scale

The early brick house on White House Farm was constructed in two principal stages. The original house, dated 1721 with glazed bricks in the north² gable, consists of a 1½-story brick house with a pitched gable roof oriented on a north-south axis. It is three bays long and one room deep, with a traditional hall-parlor plan typical of better built houses of this period in the region. The overall dimensions of the original house are 20 feet deep and 38 feet 9 inches long. This two-room plan house was enlarged at a later date by a brick addition to the south. This addition was the same width, wall height and roof pitch, and extended the house an additional 33 feet 7 inches for an overall length of more than 72 feet. The addition provides an additional two rooms on the first floor and chamber space above.

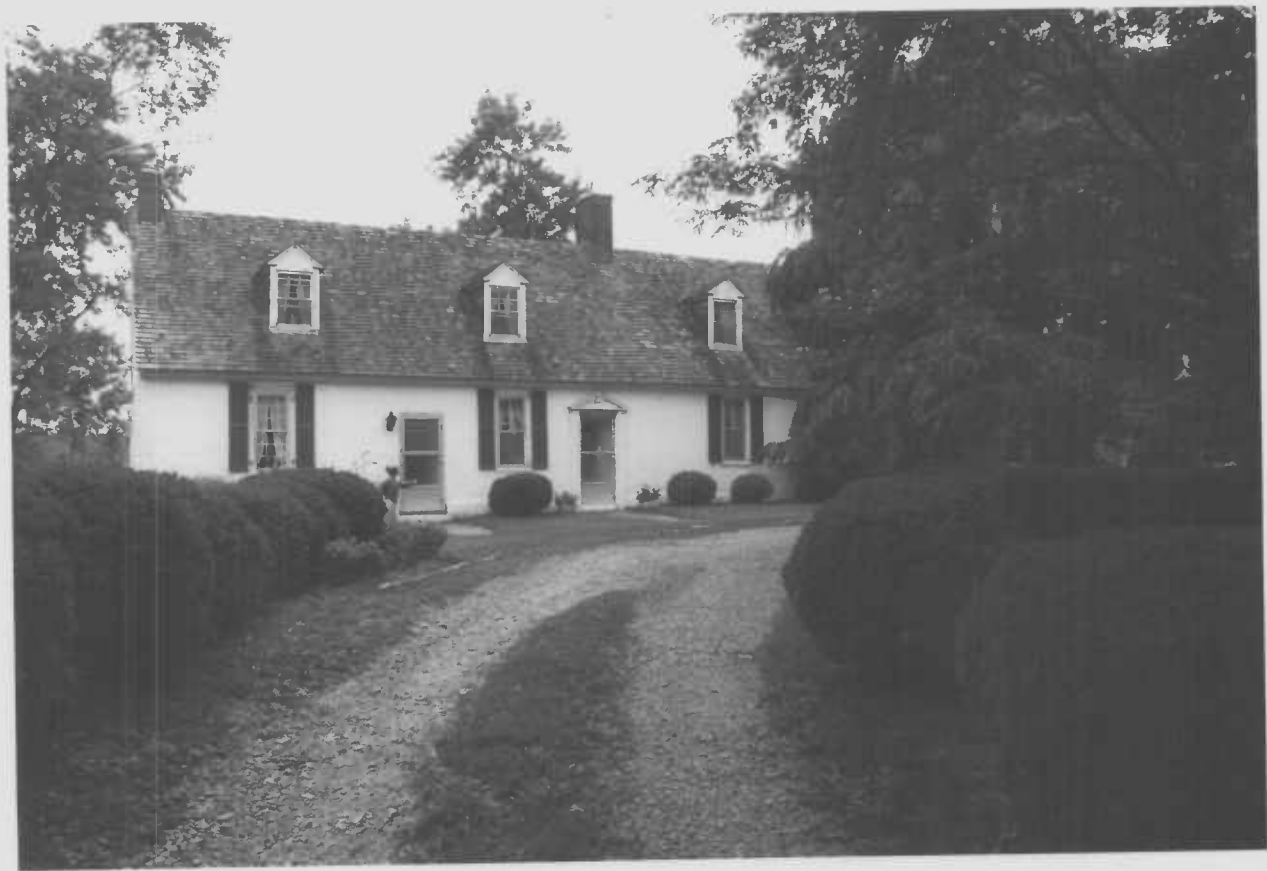
1 OF 8

EAST FACADE

The brickwork of the house is partially obscured by stucco rendering. The entire east facade of both parts is covered in this way, but the plain watertable remains evident. Faint traces of rustication are visible in the stucco, largely obscured by thick coats of whitewash, paint, and later plaster. The stucco also provides the outline of a lower gable-roofed wing, approximately 17 feet 6 inches wide, that at one time projected from the north gable of the main house. When this wing was demolished (long ago), it revealed the original Flemish bond brickwork and plain water table of the original north gable, as well as the date 1721 in glazed bricks. A cut-in door that permitted direct access from the original house to the former wing was bricked up but remains visible today.

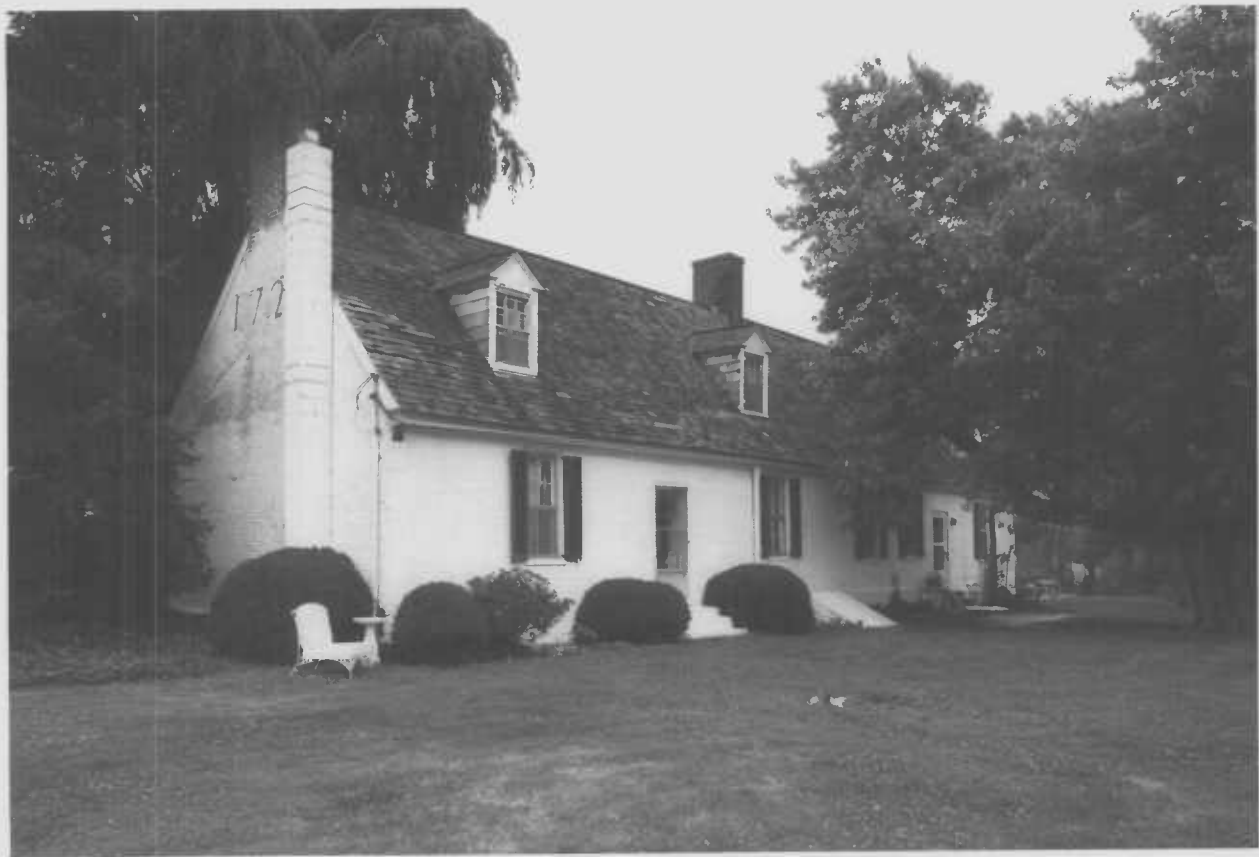
2 OF 8

WEST ELEV. & NORTH GABLE

The rear or west facade of the main house has been partially rebuilt, probably in the second quarter of the 19th century. This rebuilt section is not immediately apparent due to the heavy accumulation of whitewash and paint, but a comparison of original work at the south end of this facade, above the bulkhead cellar entrance, reveals early Flemish bond and a plain water table in contrast to the later work, laid primarily in stretcher bond with occasional header courses.

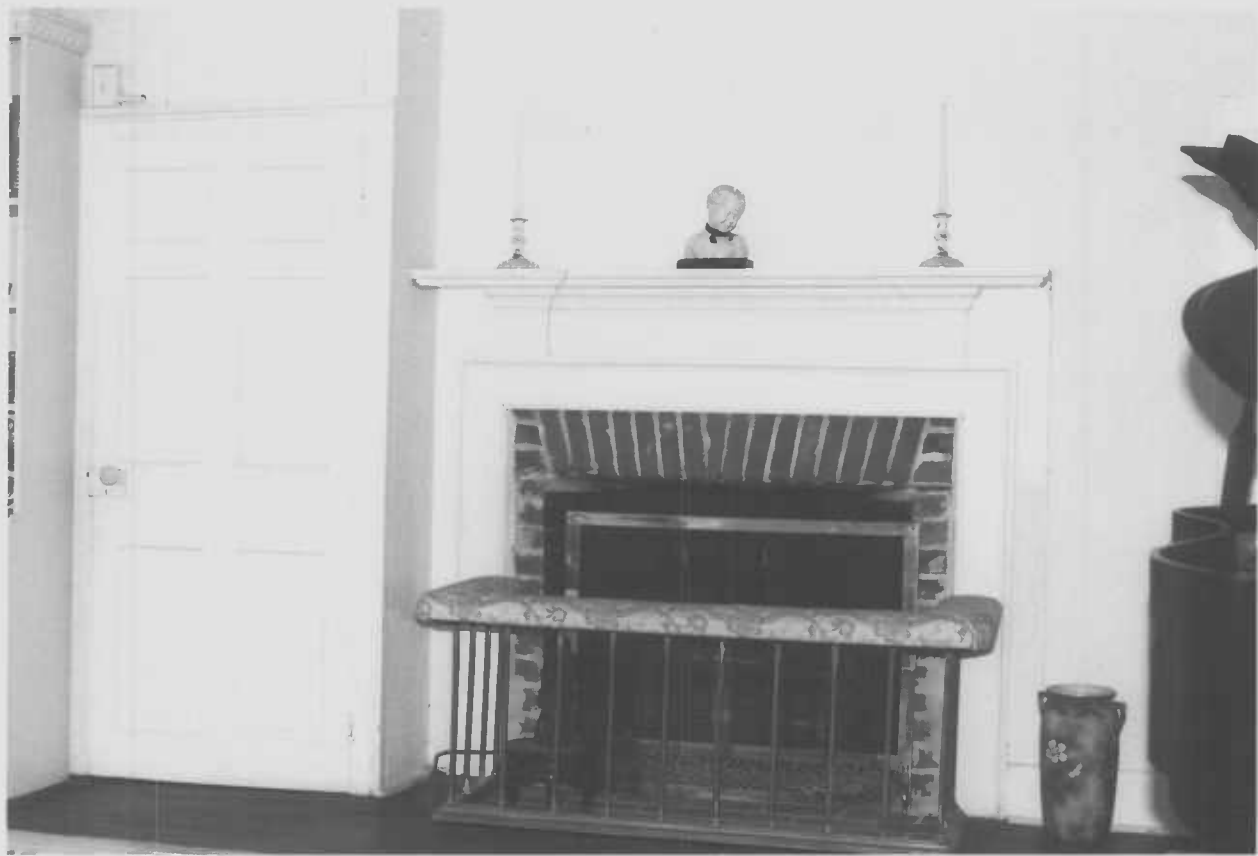
4 4 OF 8

HALL MANTEL & STAIR ENCLOSURE

The mantel in the hall is the largest and most refined in the house. It consists of a board surround with ogee-astragal backband framing the opening. Plain side blocks frame a plain frieze and support a complex molded shelf with late Federal and early Greek Revival details.

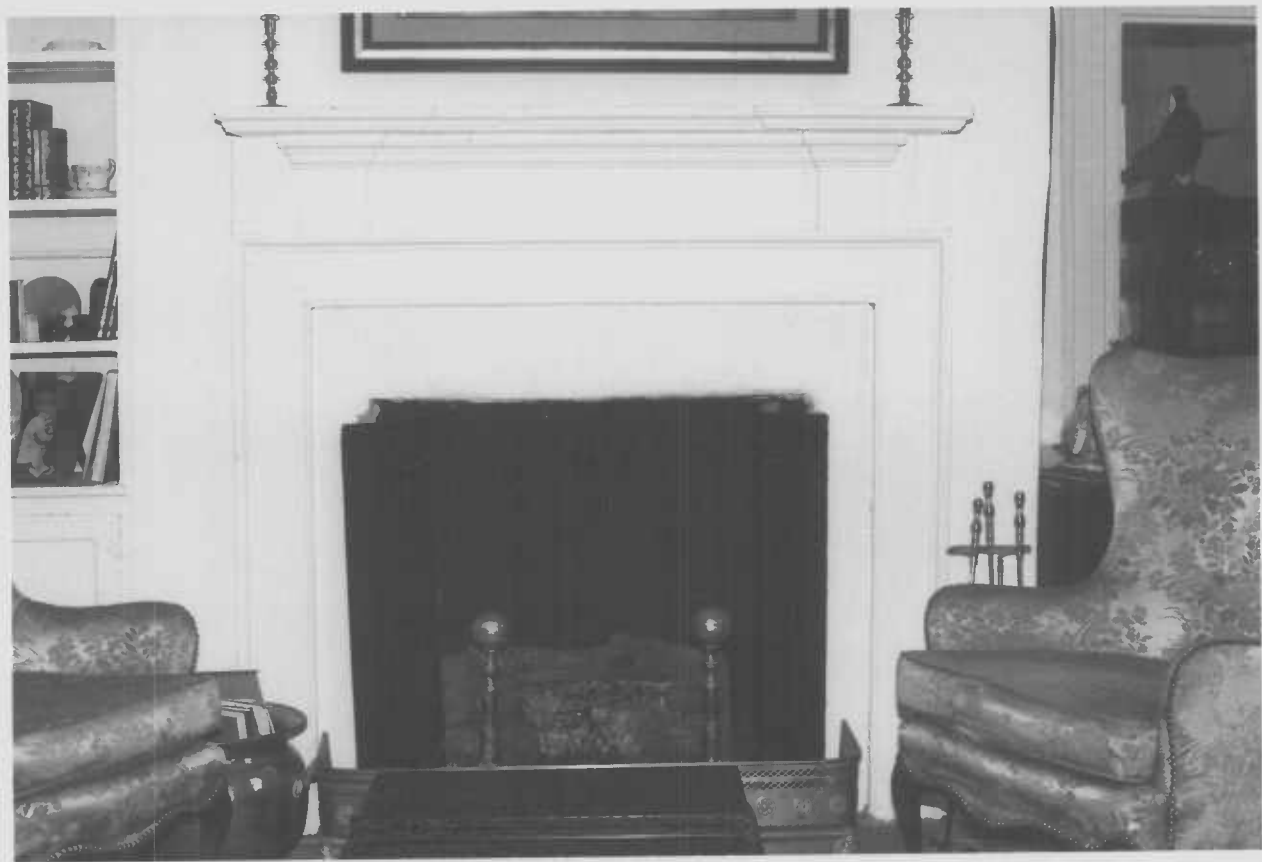
5 OF 8

PARLOR MANTEL

The parlor mantel is virtually identical to that in the hall in form and detail but is several inches narrower. This fireplace opening has been fitted with a handsome cast iron fireback and sidepieces embellished with Classical ornament, including fluted pilasters and acanthus motifs. Cast into the center piece is the inscription, "Thomas Chambers, Southampton Furnace." This fireback was found on the premises and installed during the stabilization and repair of the house by the present owners in the 1940s.

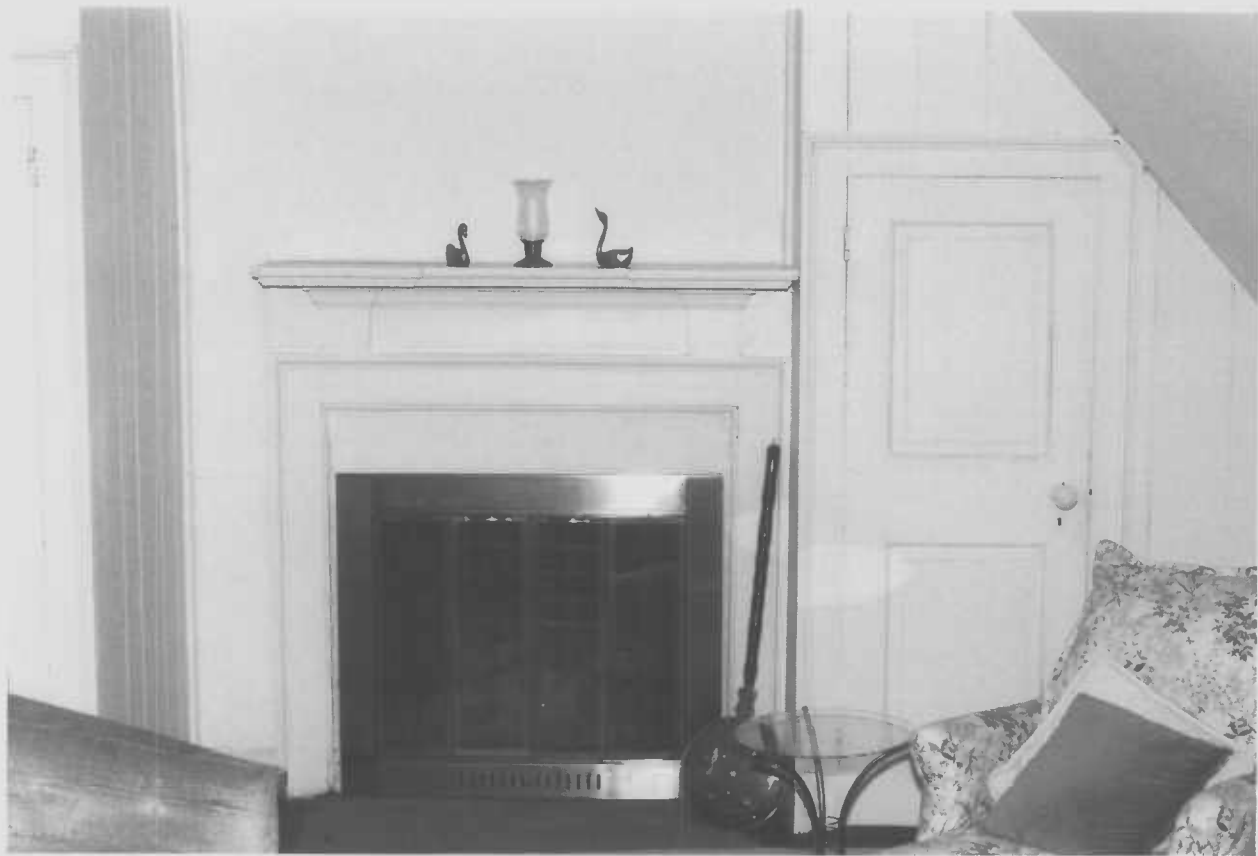
= 6 OF 8

MANTEL & CLOSET DOOR, 2D FL NORTH Room

The north chamber fireplace is fitted with a mantel comparable to the first floor mantels but smaller in scale. This fireplace is flanked by the original stair enclosure (now a closet) to the left and a small, early closet to the right. These closets are fitted with doors and architrave trim consistent with the first floor.

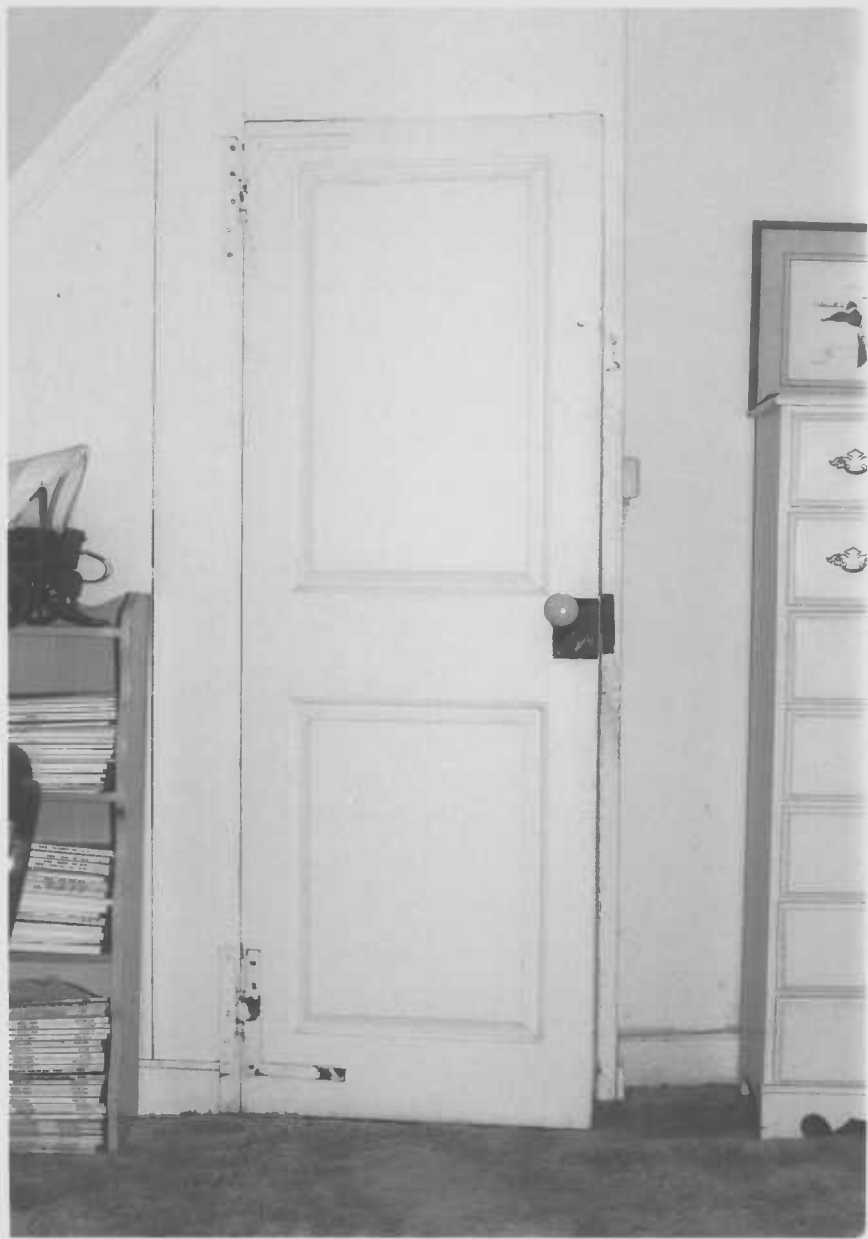
7 OK 8

2-PANEL DOOR, 2D FL

An enclosed winder stair to the left of the parlor fireplace leads up to the second story chambers. The second story was originally divided into two bed chambers, each apparently with a separate stair. The door between the two chambers is framed with the same architrave trim as found on the first floor. A two-panel door with fully raised panels is hung on unusual hand-wrought H hinges with three of the four ends foliated. An early 19th century metal box lock with brass knob remains in use.

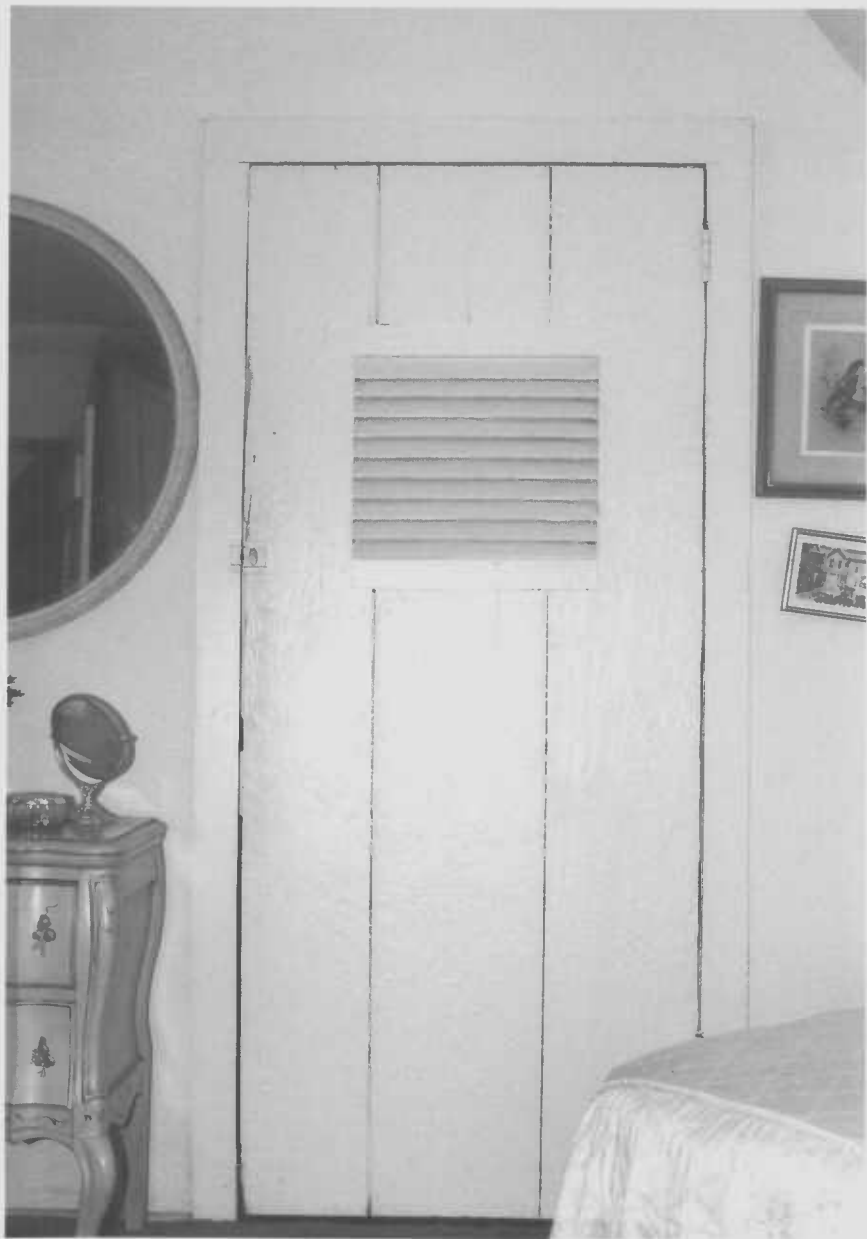
8 OF 8

LOUVERED BATTEN DOOR, 2D FL

An enclosed winder stair to the left of the kitchen chimney leads up to a room above the kitchen. This space is partitioned off from the room above the dining room by a beaded board partition. Originally, it was divided into two rather plain chambers for the kitchen servants. The ghost of the original partition remains visible on the ceiling. An interesting feature of the servants' rooms are the doors, which are of beaded batten construction with louvered vent panels fitted into the upper portion of each door.

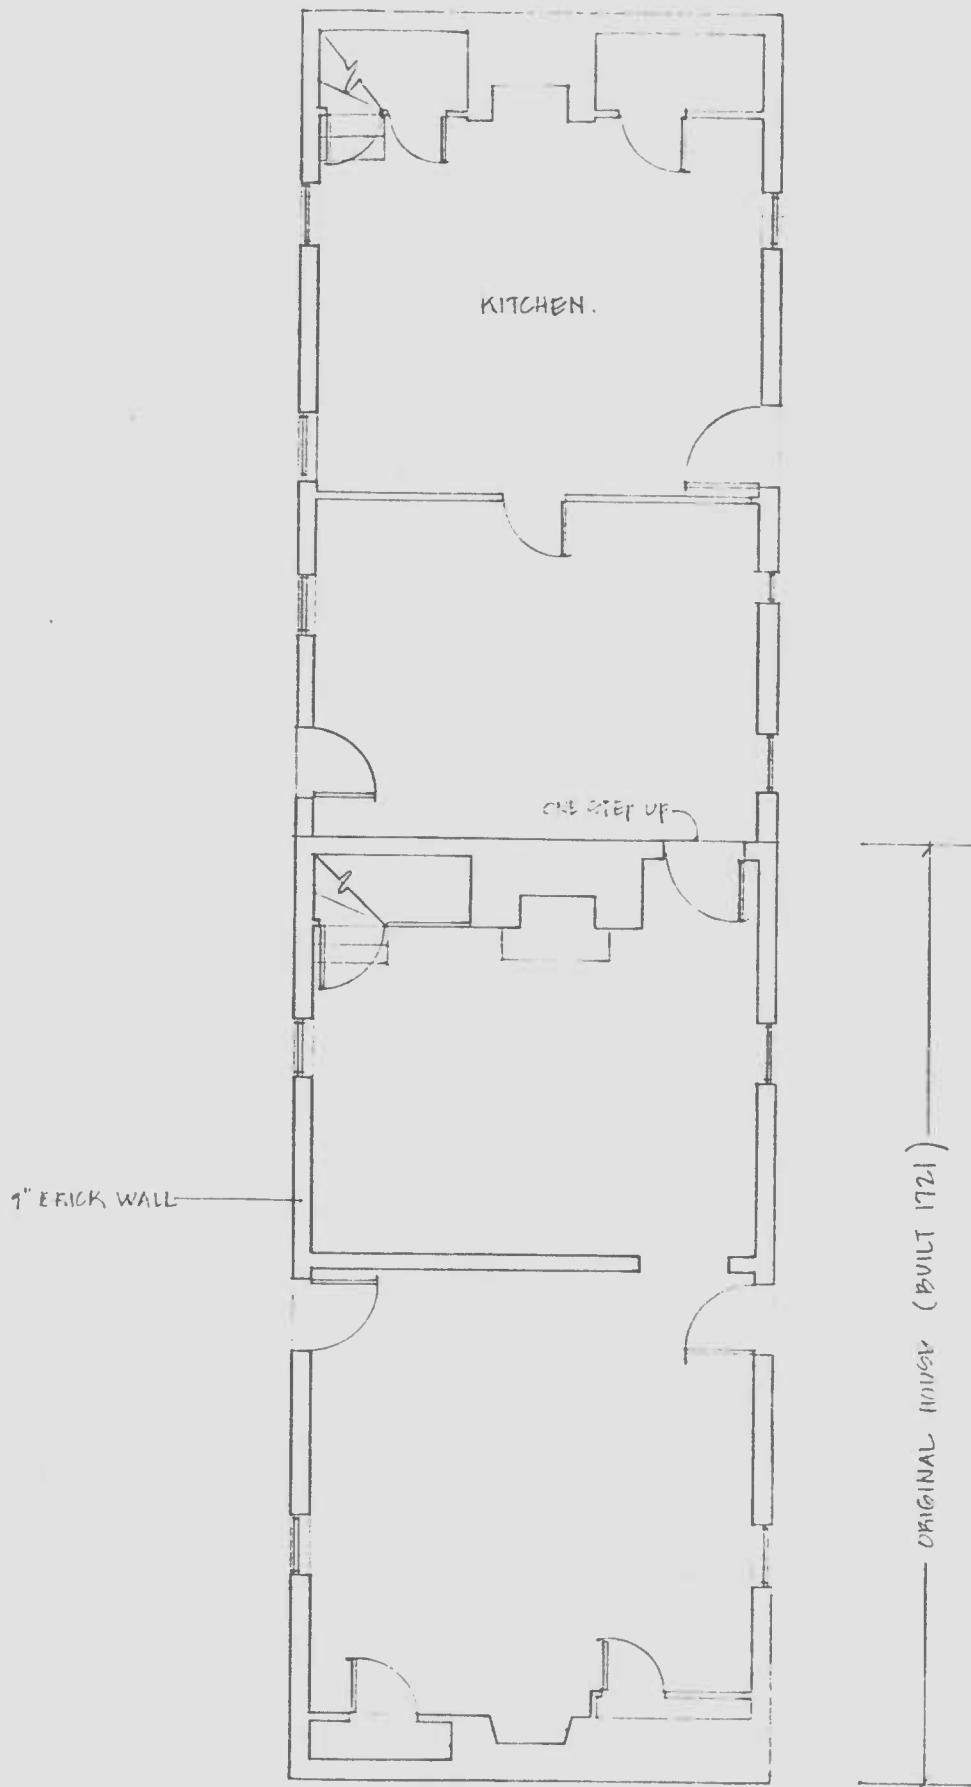
WHITE HOUSE FARM (K-203) CHRISTSTOWN, MD.
SCALE 1/8" = 10"

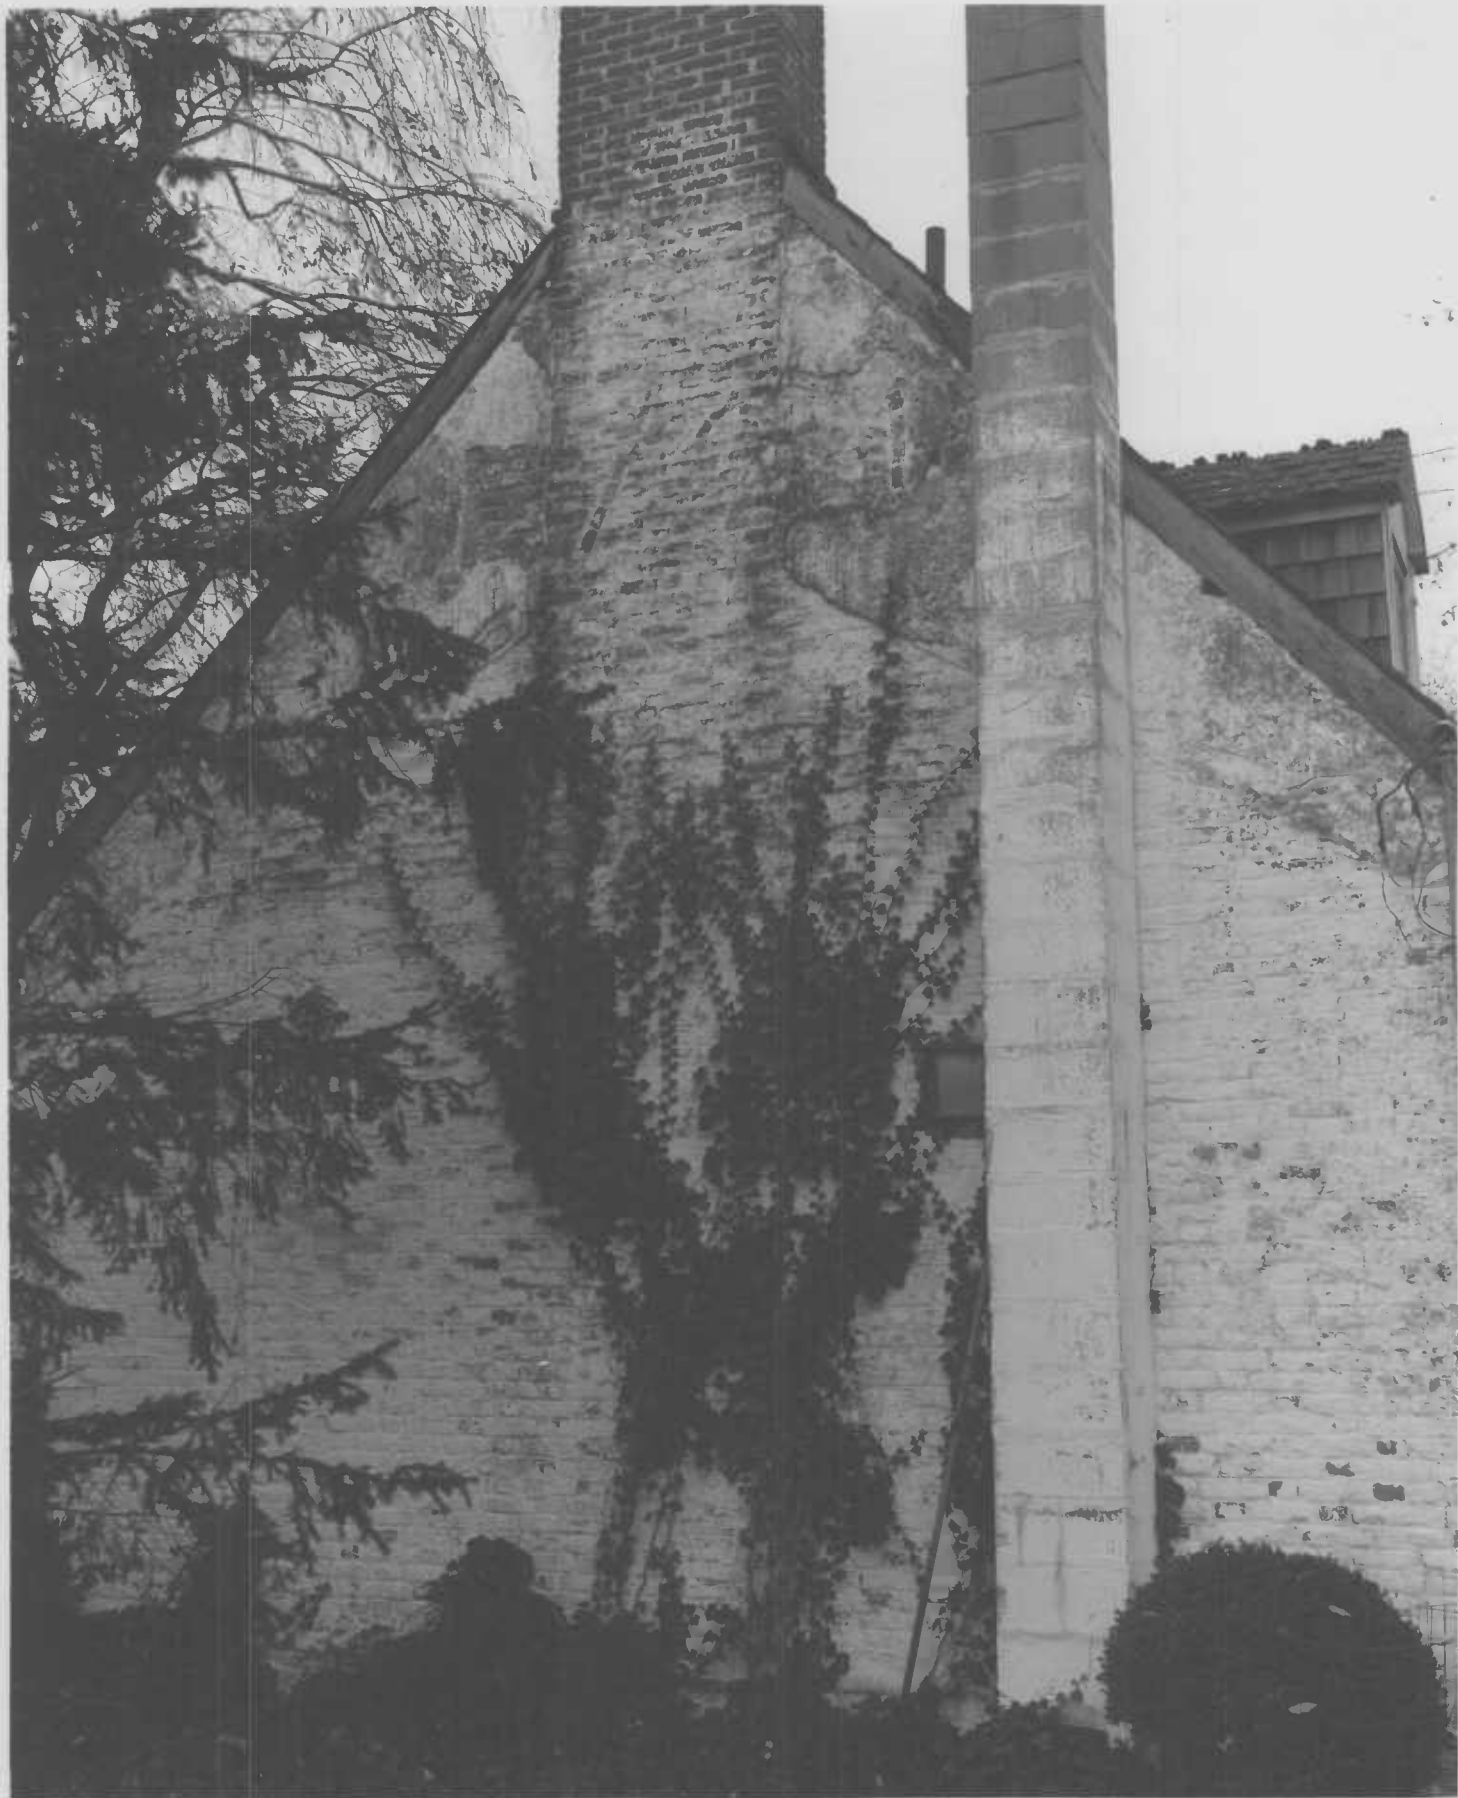
END SHOWING DATE "1721"

On the west gable of White House Farm is a date in glazed brick, 1721, the earliest such designation known on the Eastern Shore. The building is a four room long, one and one-half story brick structure with a very steeply pitched roof with dormers; the building is the same width along its length. Inside the hall and parlor plan building are paneled fireplace walls and board partitions.

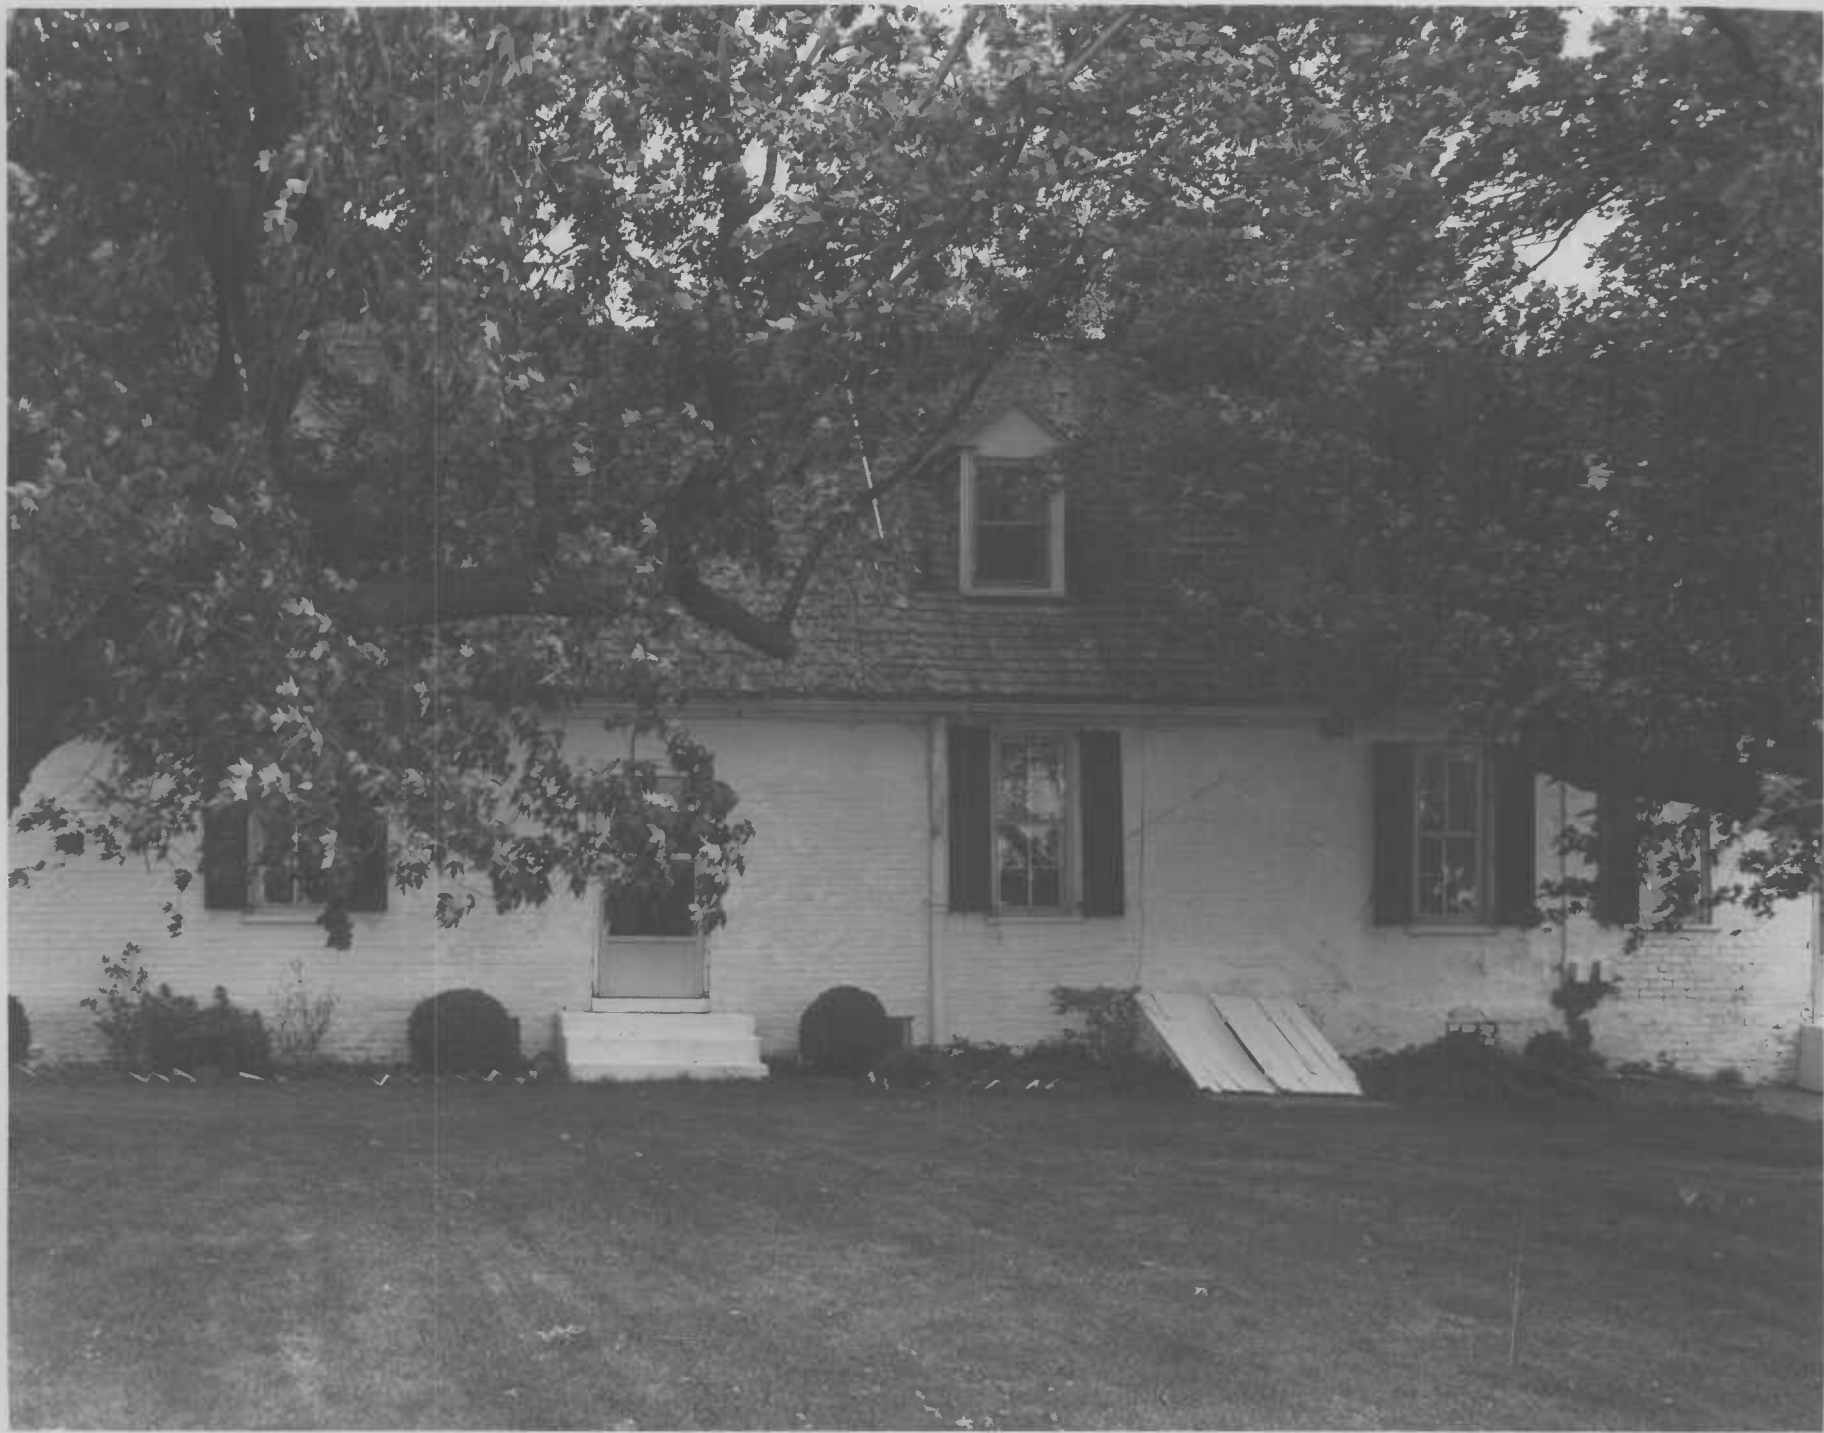
South elevation

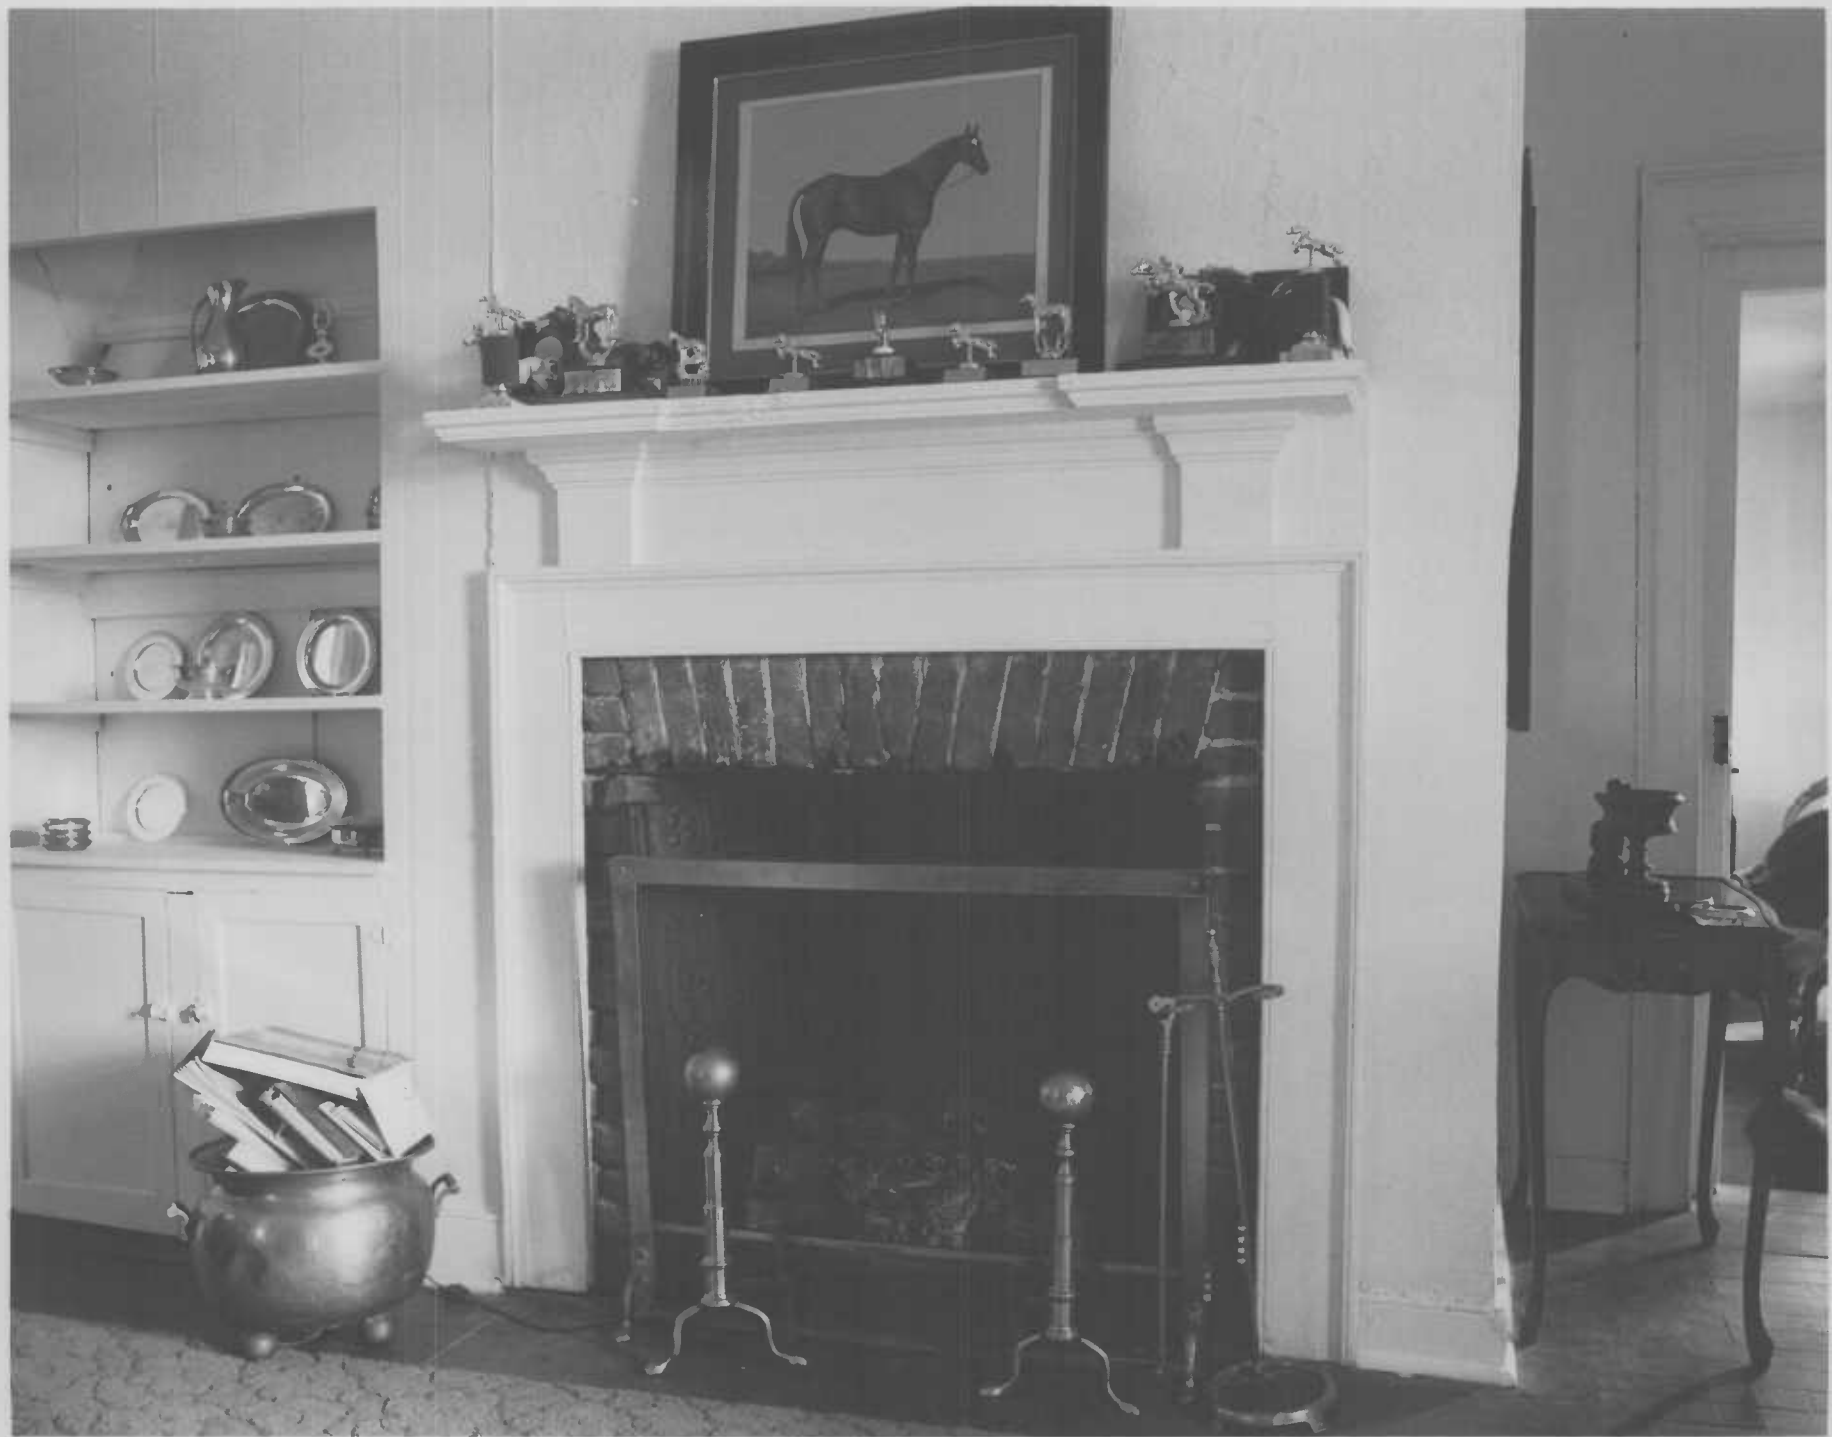
Mantle, parlour 1721 portion

In the old house, first floor, are two mantles each of which are recessed from the enclosed stair walls. Nearly identical, they have rectangular openings with beaded and molded surrounds. and shelves which are broken and rest on plain frieze blocks. Edges of the shelves and the bed moldings are of the delicate, composite type. Stairs are enclosed with wide beaded vertical boards. There are no cornices in the rooms. Window and door trim, beaded with composite backband moldings, is the same throughout the house. All doors have six raised and beveled panels.
